6. HOW TO RECOGNIZE AND PREVENT TAPERED ROLLER BEARING DAMAGE

A. Introduction

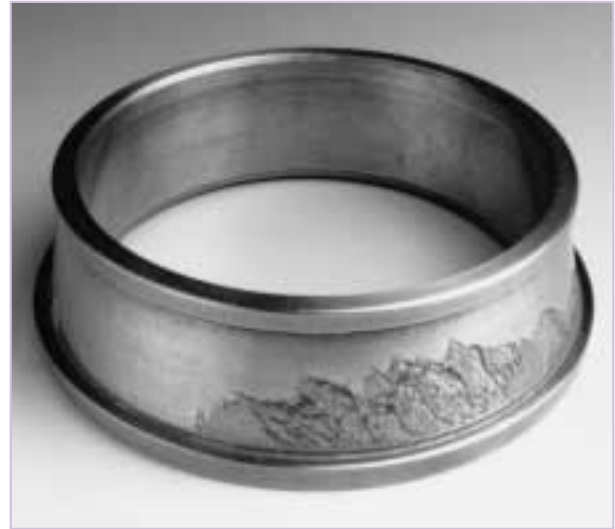
Fig. 6-1
Geometric stress concentration
Geometric stress concentration fatigue results from locally increased stress at the ends of roller/race contact.

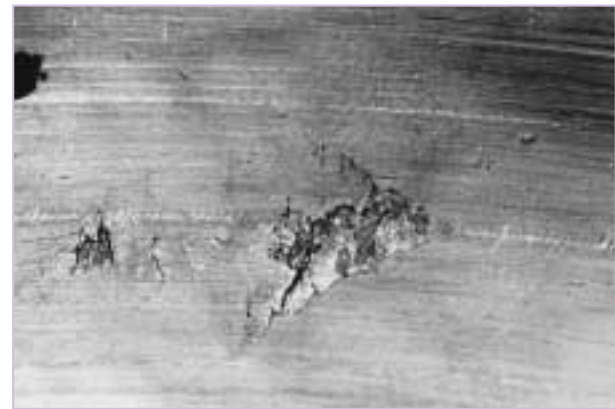
Fig. 6-2
Point Surface Origin (PSO)
PSO is fatigue damage that has its origin associated with surface asperities, which act as local stress concentrations.

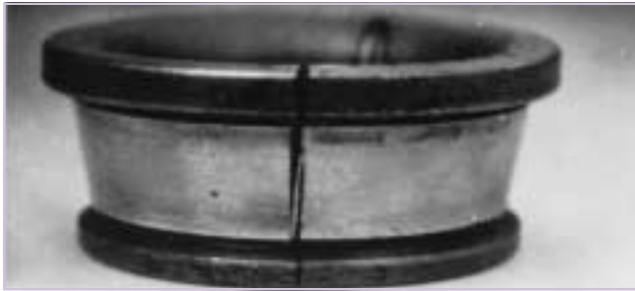
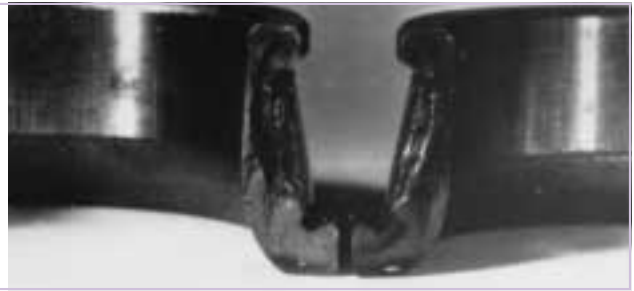
Fig. 6-4
Transverse cracking fatigue.

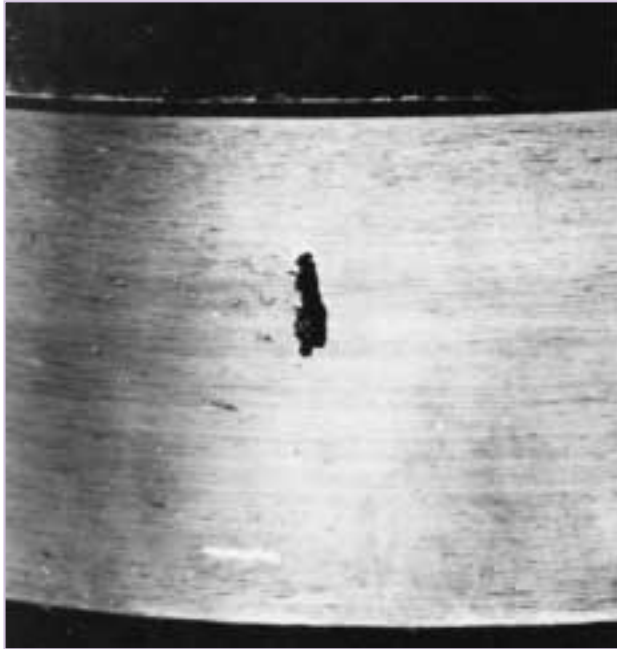
a) Non-propagated spall

Fig. 6-5
Inclusion origin spall.

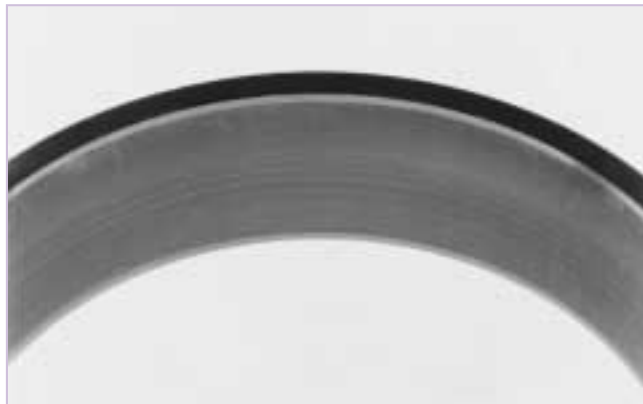
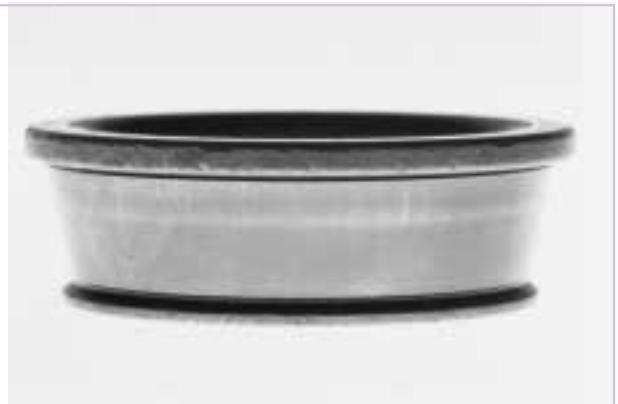
Fig. 6-6
Abrasive wear.

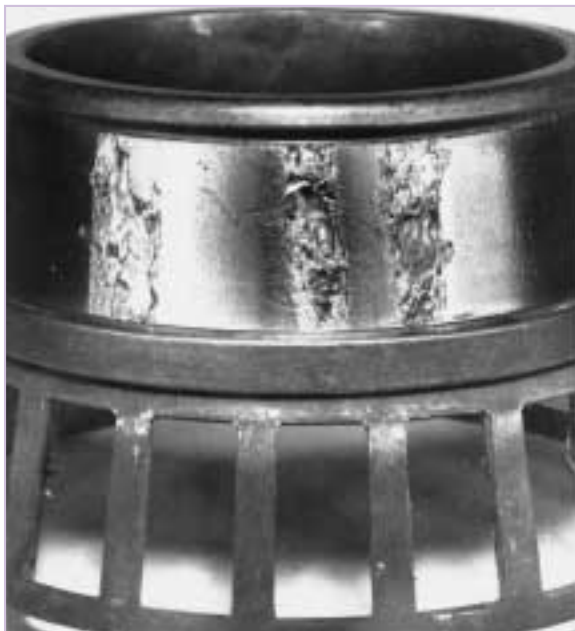
Fig. 6-7
Spalling.

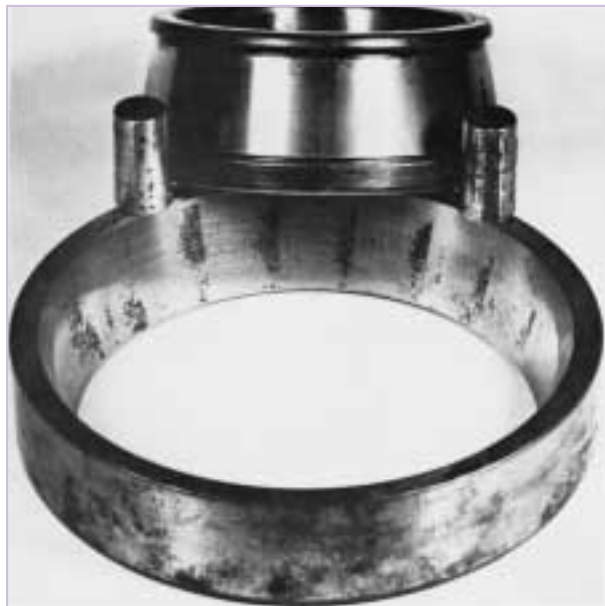
Fig. 6-9
Etching in the initial stage
Pitting caused by moisture at the roller/raceway contact line.

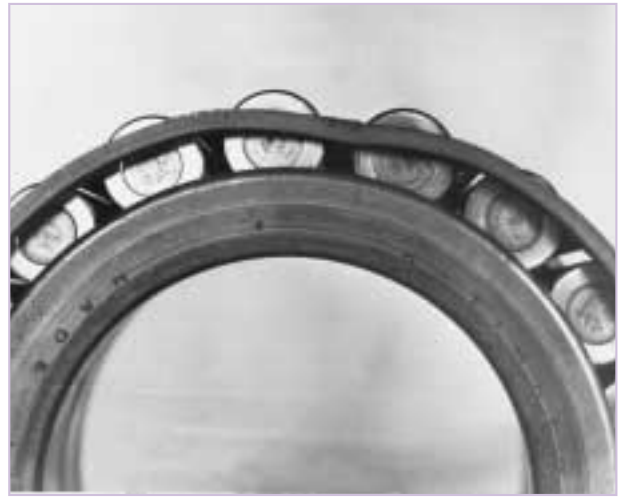
Fig. 6-12
Cage damage.

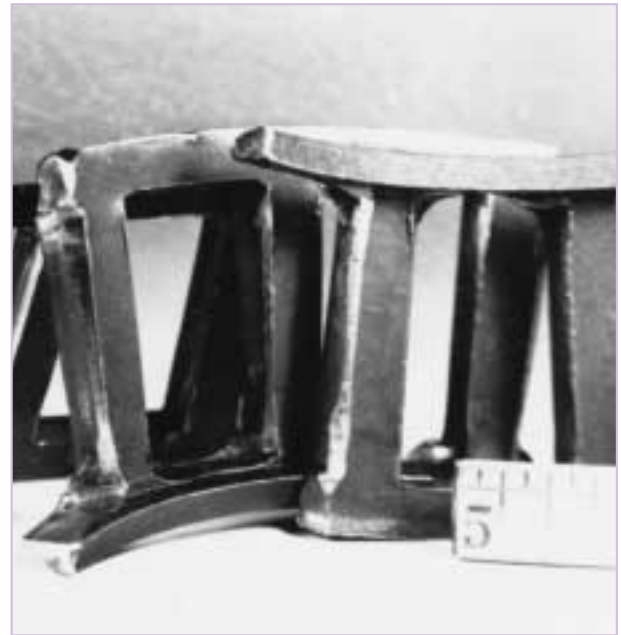
Fig. 6-13
Cage breakage.

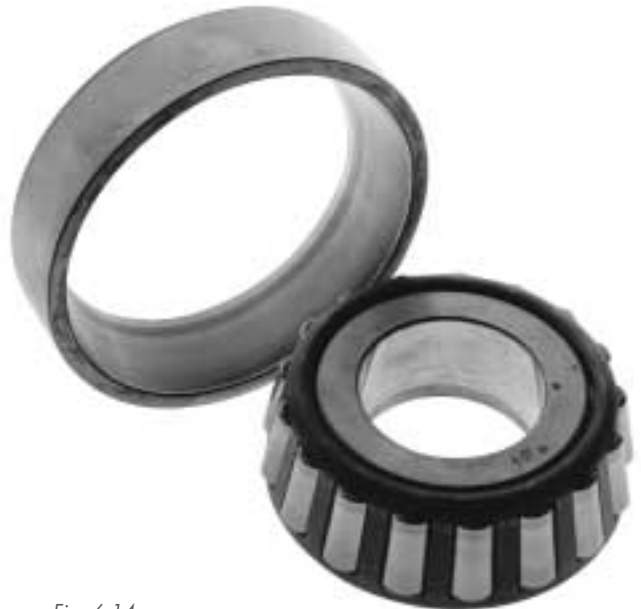
Fig. 6-14

Figure 6-14 shows what happens when there is good lubrication, good assembly and maintenance and the proper fitting practice for the bearing application has been followed. This bearing shows that, with reasonable care in machining the parts and in the assembly and maintenance, it is not difficult to get excellent life. This bearing operated for over 400,000 km (250,000 miles) in a bus and is still in excellent condition and probably would last an extended period of time.
